APPENDIX E. FIELD NOTES FROM RECONNAISSANCE

This appendix presents a summary of notes from field reconnaissance of uncharacterized exposed bank areas and selected outfalls with potential sampleability issues. This reconnaissance was performed on August 31, September 1, and September 25, 2017.

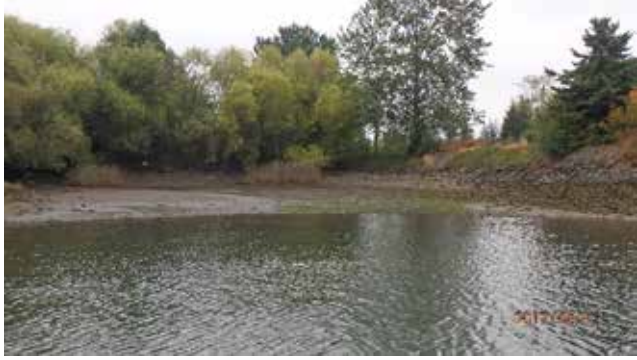
Exposed Bank Area (RM)	Field Reconnaissance Notes	Select Photos
0.6–0.7 E	<ul style="list-style-type: none"> Area is mostly exposed mud with some patches of vegetation. Large exposed area exists for potential sampling. Riprap exists around south area of bank.

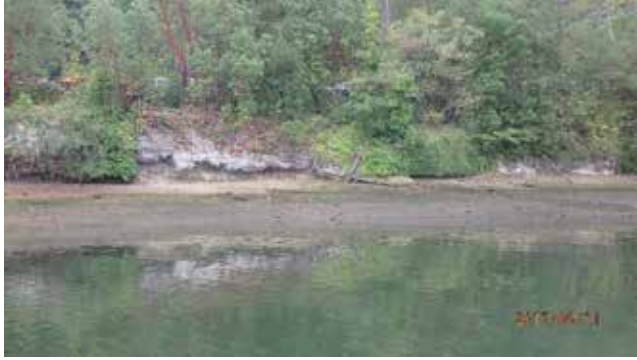
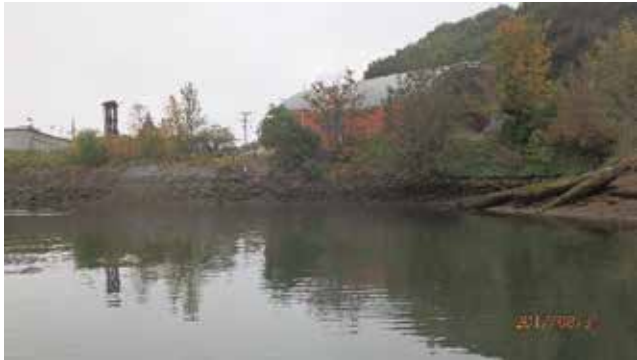
0.9–1.0 W	<ul style="list-style-type: none"> North section has large exposed area. South section has riprap but also an exposed area in the middle. Cove in south area—difficult to see entire area from boat but may be sampleable. Top portion of bank is steep, so may need to target low tide to access bank from river.

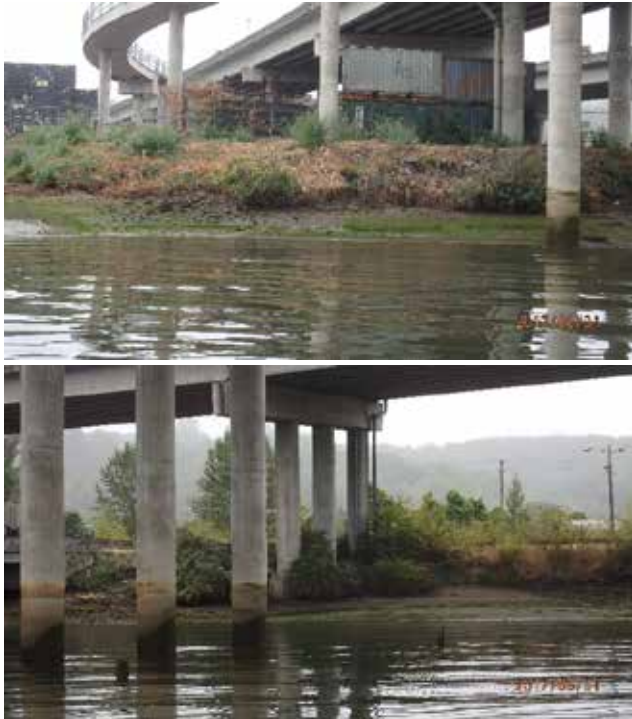
Exposed Bank Area (RM)	Field Reconnaissance Notes	Select Photos
2.0–2.2 W	<ul style="list-style-type: none"> · Bank is behind structure for 1st Avenue bridge. · Area was accessed from the south; boat access from north side of bridge seems difficult. · Small area of riprap exists on north bank area. · Most of bank area appears exposed and sampleable. · Some patches of vegetation exist. · Crew was unable to access inlet by boat.

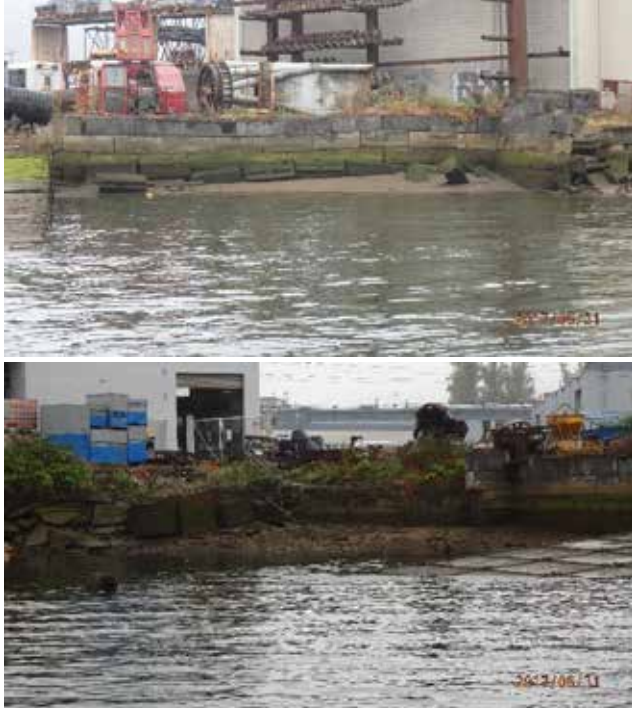
2.5–2.7 W	<ul style="list-style-type: none"> · Two ramp structures, a catwalk, and a floating dock exist. · There appear to be two sampleable areas: one may not be accessible by boat and the other is adjacent to the southern ramp structure.

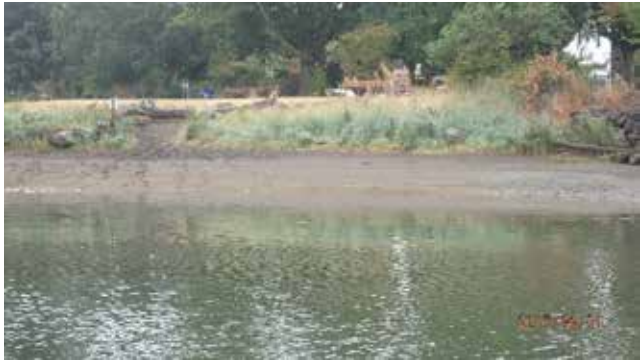
Exposed Bank Area (RM)	Field Reconnaissance Notes	Select Photos
3.0–3.1 W	<ul style="list-style-type: none"> Exposed beach area (Duwamish Waterway Park) is sampleable.

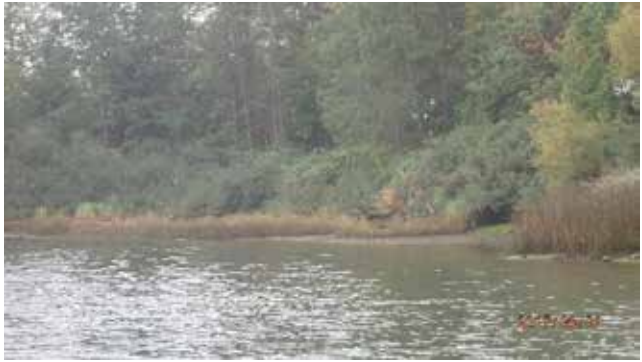
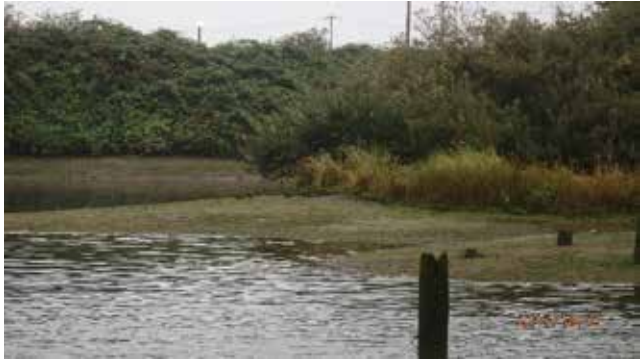
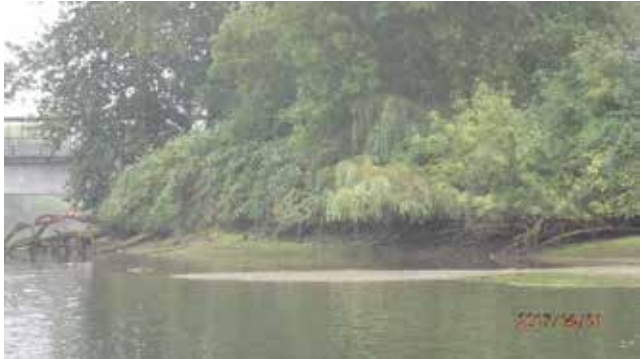
4.6–5.0 W	<ul style="list-style-type: none"> Reeds exist, especially at north end. Large amounts of vegetation exist. Some exposed areas exist throughout and in northern inlet. Southern portion of this area is not visible due to fishing boats/kayaks and bridge over river.

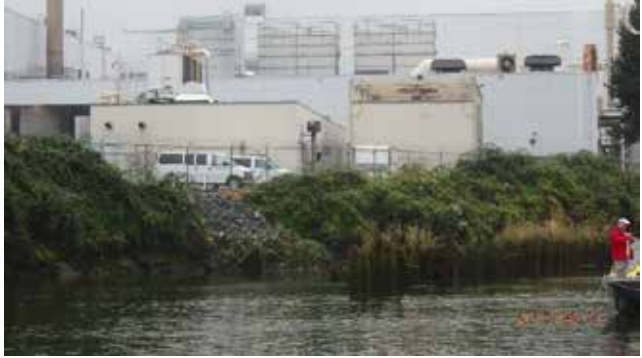
Exposed Bank Area (RM)	Field Reconnaissance Notes	Select Photos
4.7 E	<ul style="list-style-type: none"> · Lots of fisher boating activity occurs. · Riprap exists. · Slope is steep. · Dense vegetation exists. · Area did not look to be sampleable, but it was difficult to get close by boat because of fisher boating activities.

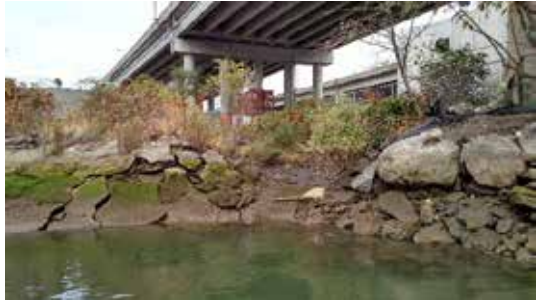
Outfall	Location (approx. RM)	Field Reconnaissance Notes	Select Photos
2503	2.0 E	<ul style="list-style-type: none"> · Team was unable to locate outfall, which was described as being at the head of a ditch. · Shoreline is armored with riprap and concrete slabs and has areas of dense vegetation.

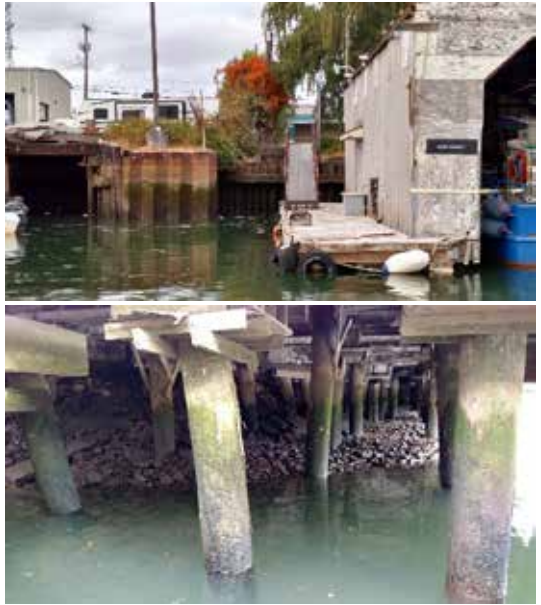
SCS Refd Services	2.1 E	<ul style="list-style-type: none"> · Team was unable to see outfall; it was likely under a structure. · A building, floating boathouse, and wooden pier structure line the shoreline, which is armored with wood piles and riprap. · The Muckleshoot Tribe fishing boats are tied up to the wooden pier.

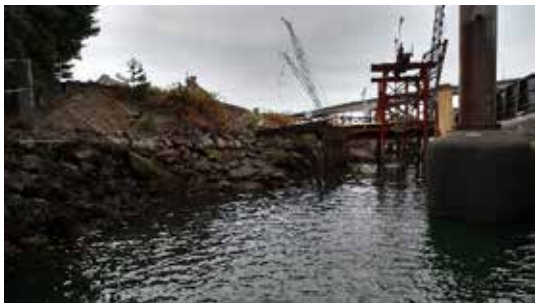
Outfall	Location (approx. RM)	Field Reconnaissance Notes	Select Photos
8134	0.0 W	<ul style="list-style-type: none"> Team was unable to see outfall; it is likely under the pier structure or behind the area where a barge was being loaded during the reconnaissance. Shoreline is armored with riprap.

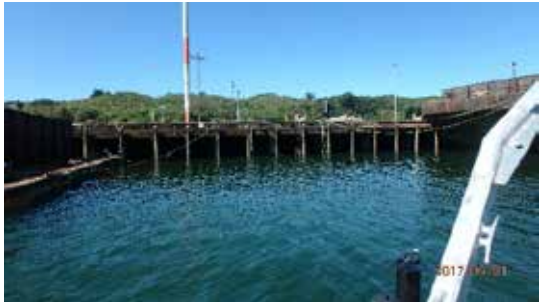
2157	0.4 W	<ul style="list-style-type: none"> Team was unable to see outfall; it was likely either under the dock or behind barges.

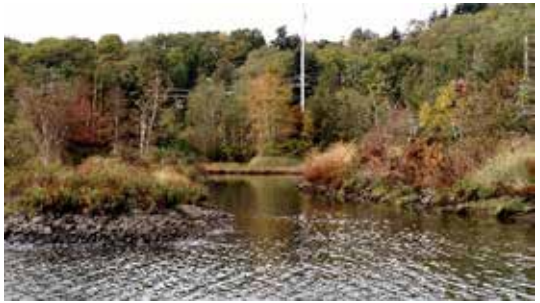
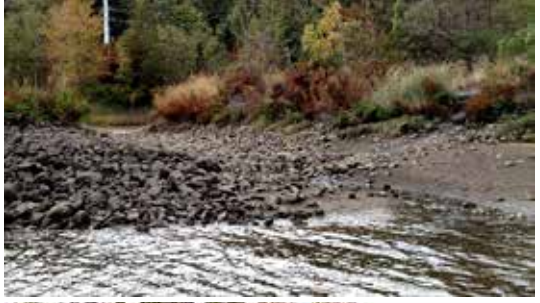
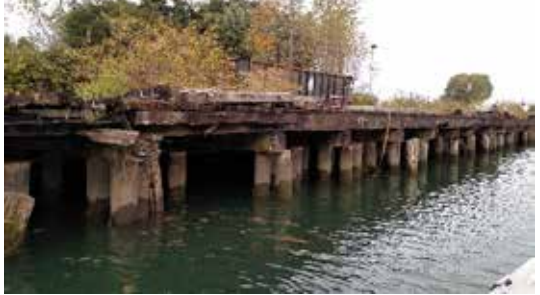
2226 (Herring's House)	0.5 W	<ul style="list-style-type: none"> There is a creek/inlet in this area that connects a lagoon to the river. The creek was observed to be at least partially armored with riprap, but may be sampleable by hand. Shoreline area north of creek/inlet is covered by a wooden pier.

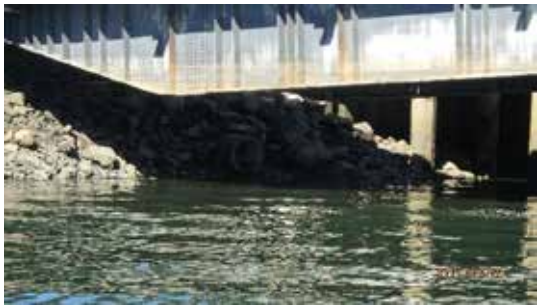
Outfall	Location (approx. RM)	Field Reconnaissance Notes	Select Photos
2220	1.8 W	<ul style="list-style-type: none"> Outfall is at edge of over-water structure. Overhead cable exists in vicinity of outfall. Riprap exists on bank in vicinity of outfall.

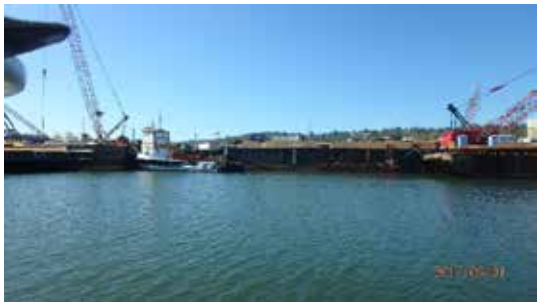
2114	2.4 W	<ul style="list-style-type: none"> Team was unable to see outfall because of boats and barges.

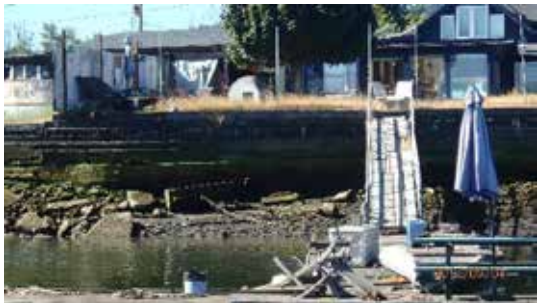
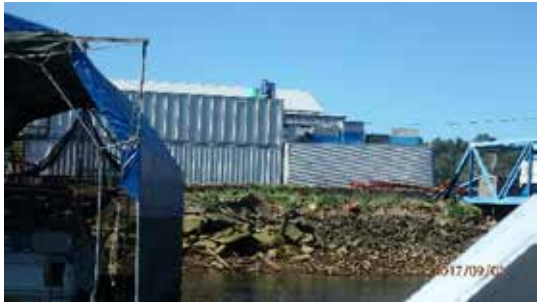
2113	2.6 W	<ul style="list-style-type: none"> Barges are present in vicinity of outfall. It is difficult to tell where the outfall is located from boat; there appears to be an outfall just south of the blue catwalk and another outfall in the retaining wall just south of the small floating dock. Riprap is present on slope but does not appear to be enough to necessarily impede sampling. Of the two observed outfalls in this area, the northern outfall is likely accessible by boat and the southern outfall may need to be sampled by land.
